# Manhole Inspection Summary

Manhole # S51A\_\_021MH

Insp Date: **5/6/08 10:28 AM**

**Location** Address: **rear 439 n kenwood ave**

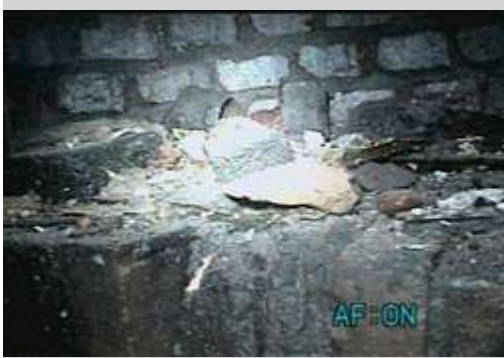
Defect 3

Condition: ☐ Sound ☐ Cracked ☐ Root Intrusion ☒ **Deteriorated** ☐ Leaks ☒ **Debris**

bench missing brick, deteriorated

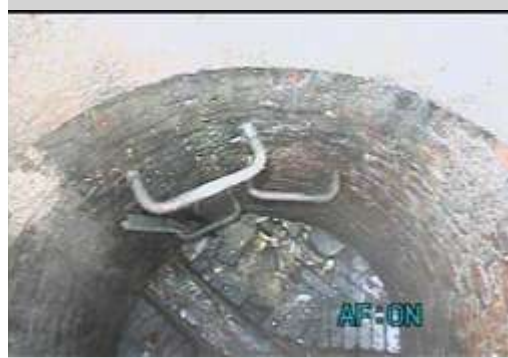
Defect 2

**Steps** Count: **3** Missing: **0** ☒ **Corroded**

steps

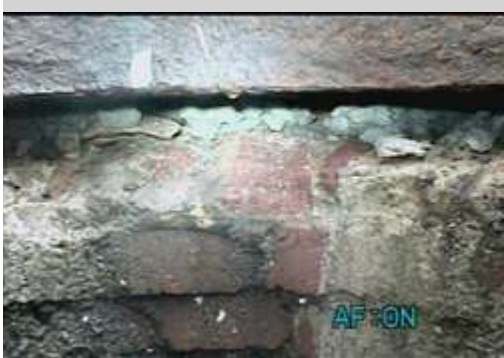
Defect 1

Condition: ☐ Sound ☐ Cracked ☐ Root Intrusion ☐ Loose Brick ☒ **Deteriorated**

chimney deteriorated, frame adjustment

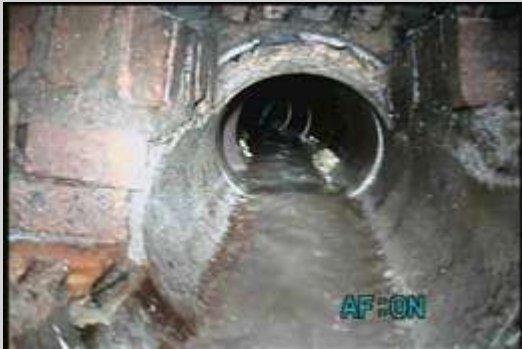
12 O'Clock Outflow

10 in. Circular Gravity Sewer  
Pipe Out @ 12 O'Clock

Pipe Material: **Clay** ☐ Pipe Lined

Invert Depth: **8.92** (ft.) Flow Characteristics: **Fast**

Infiltration: **None** Pipe Seal Cond: **Unknown**

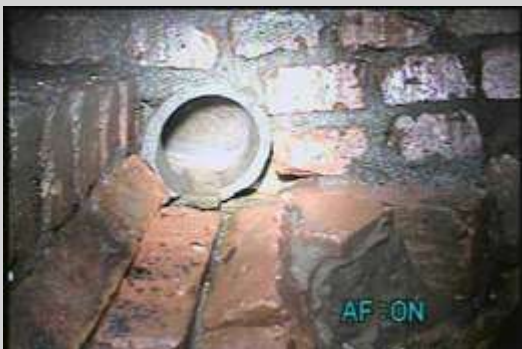
5 O'Clock Inflow

8 in. Circular Gravity Sewer  
Pipe In @ 5 O'Clock

Pipe Material: **Clay** ☐ Pipe Lined

Invert Depth: **8.06** (ft.) Flow Characteristics: **None**

Infiltration: **None** Pipe Seal Cond: **Unknown**

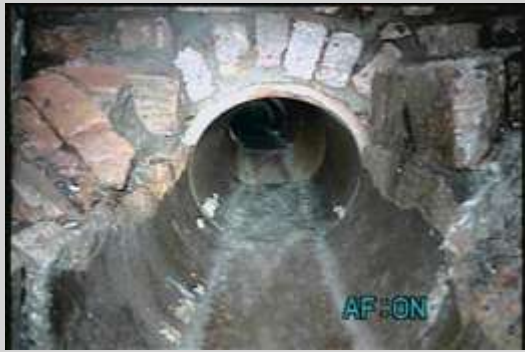
6 O'Clock Inflow

10 in. Circular Gravity Sewer  
Pipe In @ 6 O'Clock

Pipe Material: **Clay** ☐ Pipe Lined

Invert Depth: **8.88** (ft.) Flow Characteristics: **Fast**

Infiltration: **None** Pipe Seal Cond: **Unknown**

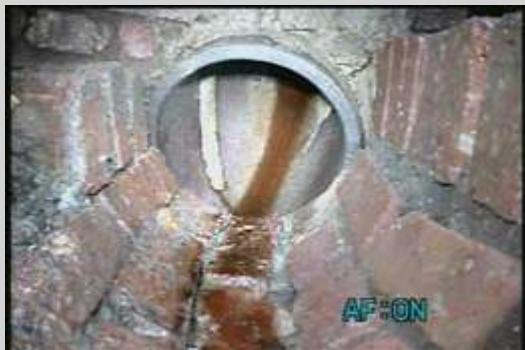
9 O'Clock Inflow

8 in. Circular Gravity Sewer  
Pipe In @ 9 O'Clock

Pipe Material: **Clay** ☐ Pipe Lined

Invert Depth: **8.41** (ft.) Flow Characteristics: **Fast**

Infiltration: **None** Pipe Seal Cond: **Unknown**
